CIVIL AERONAUTICS BOARD

ACCIDENT INVESTIGATION REPORT

NORTHWEST AIRLINES, INC.—MT. SANFORD, ALASKA—MARCH 12, 1948

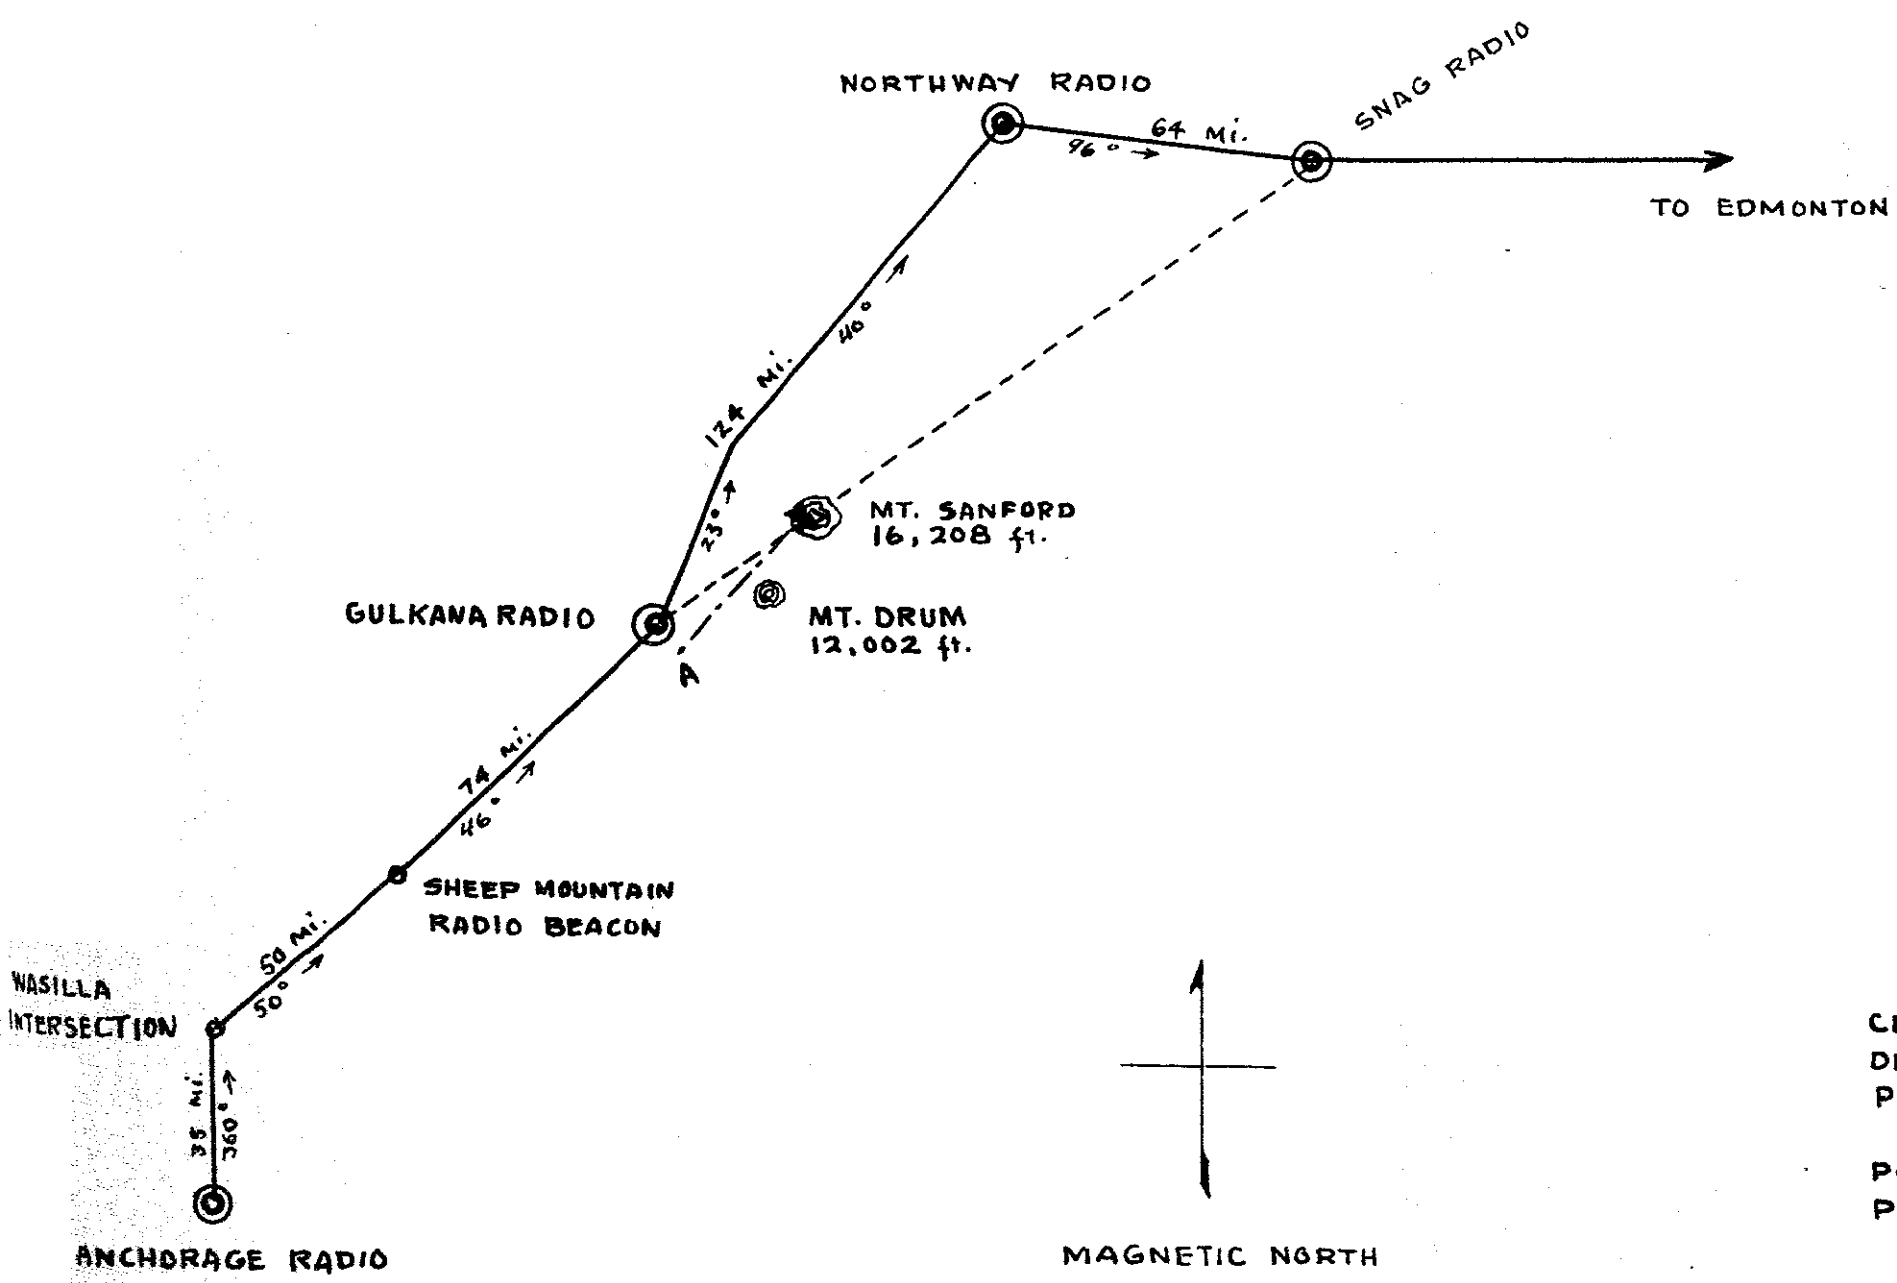
CHART OF AIRWAY FROM ANCHORAGE TO SNAG

Since the aircraft was observed to fly easterly from Gulkana, at which time it was 4 miles south of the Gulkana radio range station, it appears that the flight was not following the airway, but was flying directly from Gulkana to Snag. It is probable that the pilot, relying on good visibility, felt confident that he would see Mt. Sanford and be able to safely circumnavigate it. Though no clouds were reported, the top of Mt. Sanford could very well have been capped by a thin layer of clouds. Such a layer of clouds would not only have tended to obscure the mountain but may have acted as a reflector for the aurora borealis which was observed to be particularly brilliant the night of this flight.

8. The aircraft crashed approximately 42 miles 51 degrees from the Gulkana radio range station on Mt. Sanford at its cruising altitude of 11,000 feet, and 23 miles southeast of the center line of the airway as described above.

CENTER LINE OF AIRWAY
DIRECT COURSE GULKANA TO SNAG
POINT "A" - AIRCRAFT OBSERVED FLYING
EASTERLY FROM THIS POINT.
POINT "X" - APPROXIMATE POINT OF CONTACT.
PROBABLE COURSE OF AIRCRAFT.
